The Farmers' Tower: The Development of the Tower Silo

Loran Berg

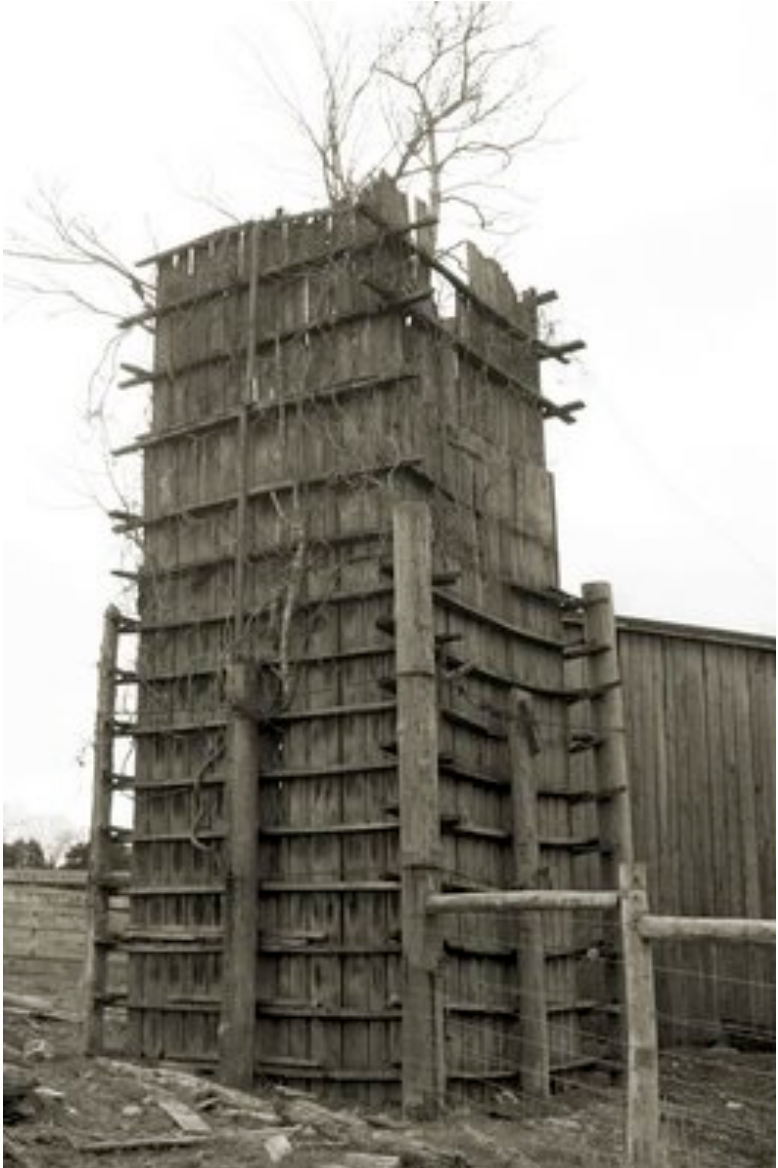
Figure 1: Rectangular silo built on the exterior of a barn. Note the substantial efforts at additional structural support and bracing to hold back the pressures of the silage. Location unknown.

Both interior and exterior rectangular silos usually employed a framed construction method. The framed building technique was familiar to farmers, as all farm buildings were built in this manner. The technique worked well for most needs, but for silos it was insufficient and not suited to holding back the pressures generated by substantial amounts of heavy silage in a tall stack. Because of the weight of silage, many of these silos burst or had a wide variety of problems causing many to be torn down and the lumber reused, or simply abandoned or

destroyed. (Figure 1) Subsequently, there are only a small number of these early silo forms in existence today.⁷

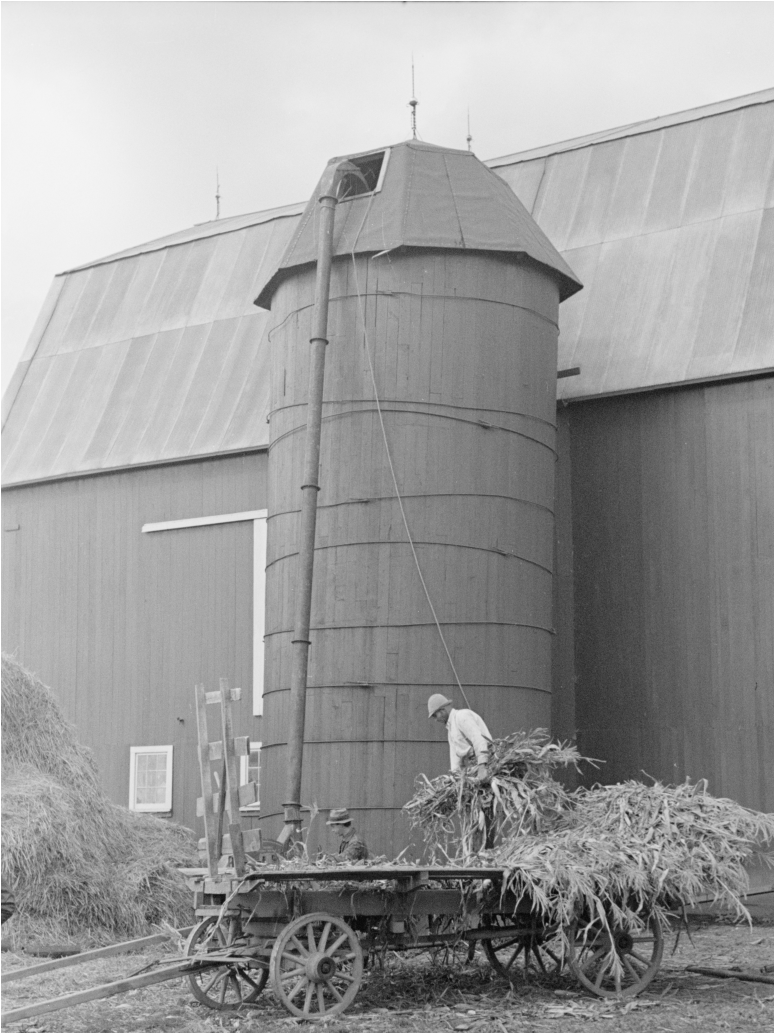
Figure 2: Wooden stave silo in Tompkins County, New York, September 1937.
Source: Library of Congress, U.S. Farm Security Administration, Office of War Information.

The silo was built in a variety of designs using wood. The most commonly built type was the wood stave silo. (Figure 2) Stave silos consisted of long planks placed upright on a foundation. The boards used varied in quality and shape. Some farmers used an ordinary plank and nailed it to its neighbor using another strip of wood as a joining agent. A more sophisticated method used tongue and groove joints that were spiked together. Silos of this variety could be ordered as a kit and were sold by regional equipment dealers. Different species of wood were available with pine being the cheapest variety and cypress or redwood being the highest. Different species of wood resulted in the stave silo lasting either for a shorter or longer duration, respectively. On occasion the lower quality woods, such as pine, were coated with a creosote solution to slow the decay of the wood, which also gave the silo a darker color. The stave silo proved to be the most popular type of wood silo construction due to the ease of construction, ready availability of materials, and farmers' familiarity with the construction method. Stave silos were really just very large barrels, built much like the barrels crafted by the local cooper complete with staves and iron bands. Large water tanks, such as those used by the railroad and seen across the country, were also built in this manner.⁸

All stave silos required the use of metal hoops to hold them together. As the silo rose higher, threaded hoops were placed around the entire structure to hold the staves together. The hoops needed to be adjusted periodically as the silo was filled and emptied, and these adjustments came to be one of the primary disadvantages of the wood stave silo. The hoops needed to be loosened when filled to prevent the staves from being crushed under the hoops, and then tightened when empty to prevent the structure from falling over in strong winds.⁹

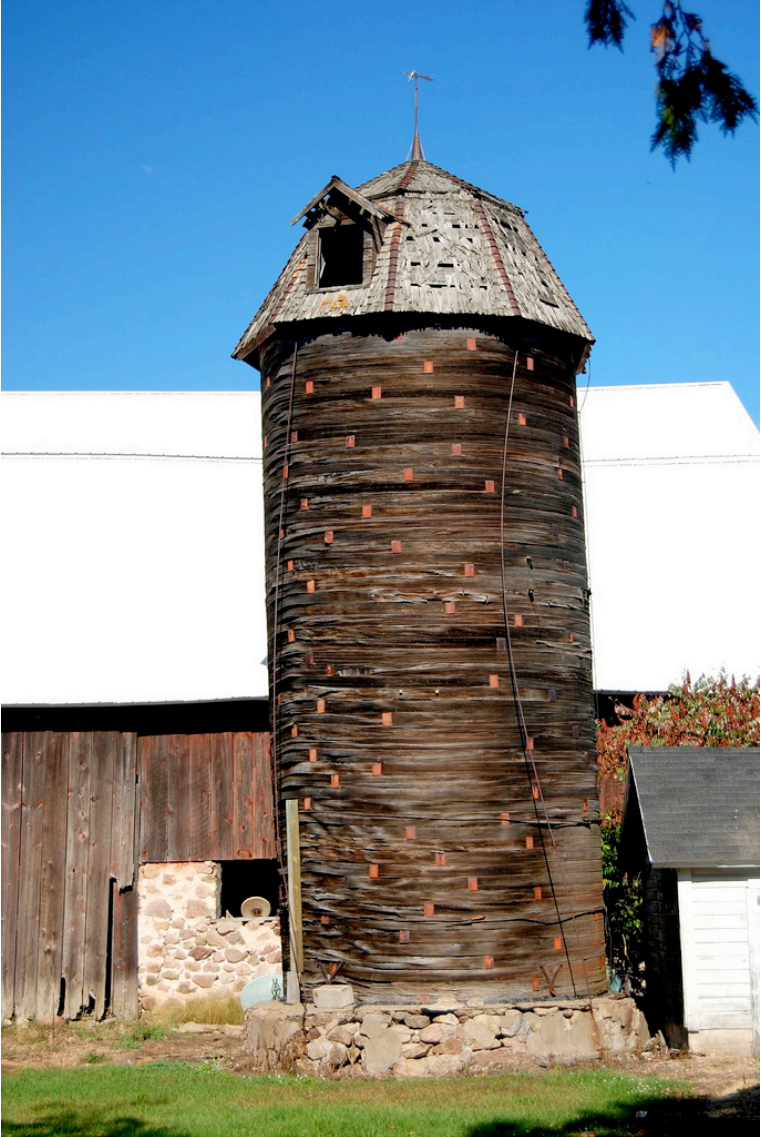
Figure 3: Wooden hoop silo near Gresham, Wisconsin. Note the dormer on the roof.

There were also other variations in wood silos. One interesting type was the hoop silo. (Figure 3) Long planks of wood the length of the diameter of the silo were thoroughly soaked in water and then bent around a heavy framework, secured together and then allowed to dry, which created a huge hoop. The silo walls were then built of stacked hoops. Hoop-built silos were never widely popular due to the slow and exacting building process involved and the high degree of hoop failure that occurred. A secure way of keeping the opposing forces in the silo walls together for an extended period of time never developed.¹⁰

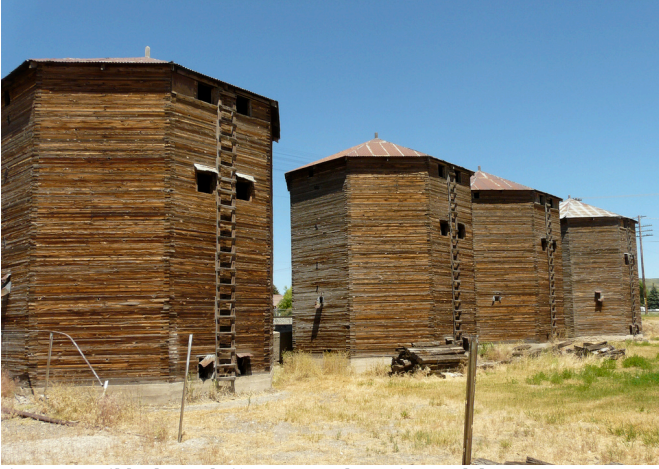
Figure 4: Cribbed wood silos near Soda Springs, Idaho.
Photographer: Zetrules

The final wood-built silo technique is cribbed construction. (Figure 4) With this technique builders borrowed a construction method used by the towering grain elevators that dotted the countryside along railroad lines. Planks measuring two inches by six or eight inches, depending on the diameter of the silo, were laid flat one on top of another and then spiked together. The boards were sometimes staggered to vary the seam in the structure making it stronger. Cribbed construction created a hexagonal, octagonal, or decagonal structure rather than a round structure. Corners still existed, but the resulting angles were much larger, thus decreasing the problem of poor packing. Cribbed silos were physically attractive, stable, and incredibly strong, but required a massive amount of lumber and therefore seldom made outside of areas with large amounts of wood available. Cribbed silos were also sometimes built out of the salvaged timbers of unused barns, silos, or other farm buildings.¹¹

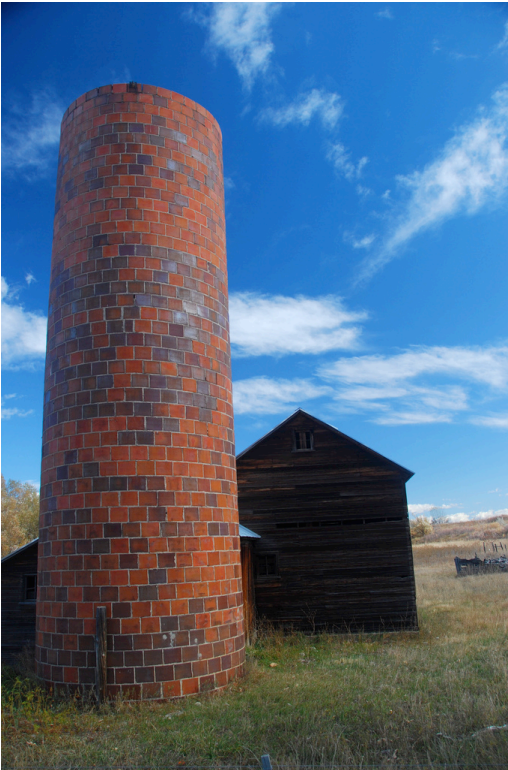
Figure 5: Fired clay tile silo located near Boulder, Colorado.

There were several different types of masonry construction. A wide variety of materials were used in the construction of silos. Brick was a natural candidate; however, they were not usually used because of their high cost and the need for skilled labor in the construction process. After the development of natural gas in the early 1900s, cheap gas-fired ceramic hollow blocks became a material of choice. (Figure 5) Extremely popular, these ceramic block silos are still seen standing on many farms in the Midwest. Ceramic building material was durable, attractive, and helped insulate the silage from freezing. The dark brown and glossy appearance of fired tile proved to be a popular addition to farmyards and some companies offered farmyard “kits” that included tile barns, silos, and other miscellaneous outbuildings in a coordinating scheme. Kits were obviously quite expensive and proved to be short-lived, as farmers seldom wanted the added expense of coordinating their farmyards with a unifying construction material theme at an added expense.¹⁴

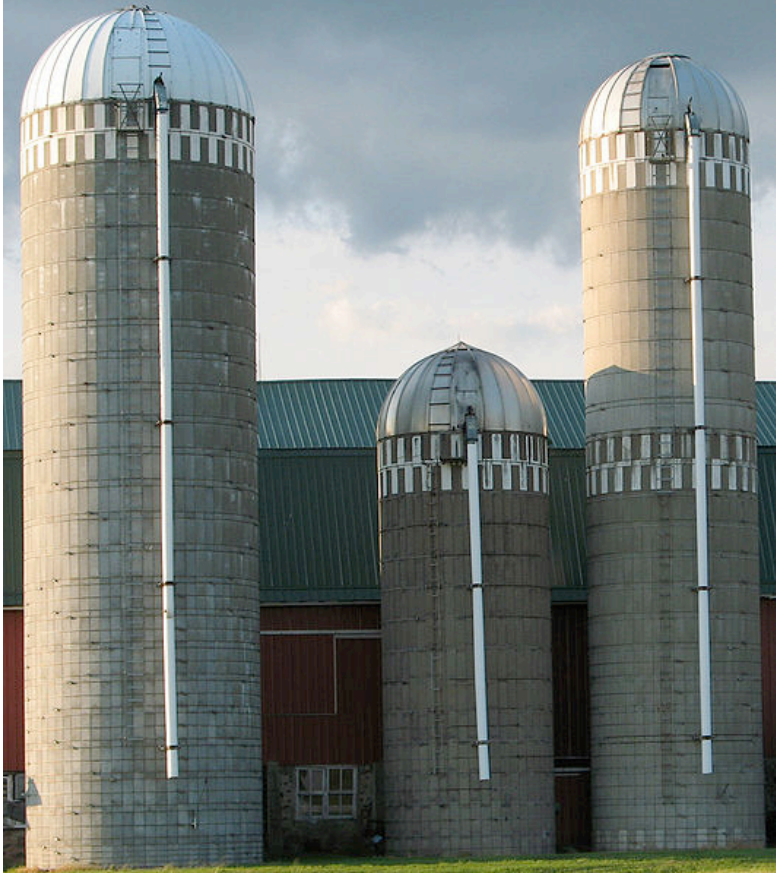
Figure 6: Concrete stave silos of varying height and diameter. These silos are built with automatic unloaders, seen by the use of small diameter chutes on the side of the structure. This type of silo is still built today. Location unknown.

Another form of concrete construction was closely related to an earlier design. The wood stave silo inspired the concrete stave silo. (Figure 6) The concrete stave silo was built much like the wood stave silo except that the concrete staves were usually only approximately 30 inches long. Short staves were built so they could interconnect with one another. As the silo gained height, bands much like the bands used on wood stave silos were placed around the structure to hold it together. This allowed the farmer to add to or remove height as need or financial ability allowed. (A silo showing this growth is on the right-hand side of Figure 6; note the band of colored staves near the middle, showing that this layer was once the top of the silo.) The concrete stave method was quite popular and many of these silos are still seen and built today in the Midwest. They are distinctive in their appearance due to the vertically striped look and the decorative elements that builders tended to include near the top such as contrasting colored staves in an alternating or solid band. The concrete stave silo was the first style that was universally popular in not only the Midwest, but the rest of the country, therefore becoming the standard in the silo “look.” Consequently, the concrete stave construction technique is still used today.¹⁷

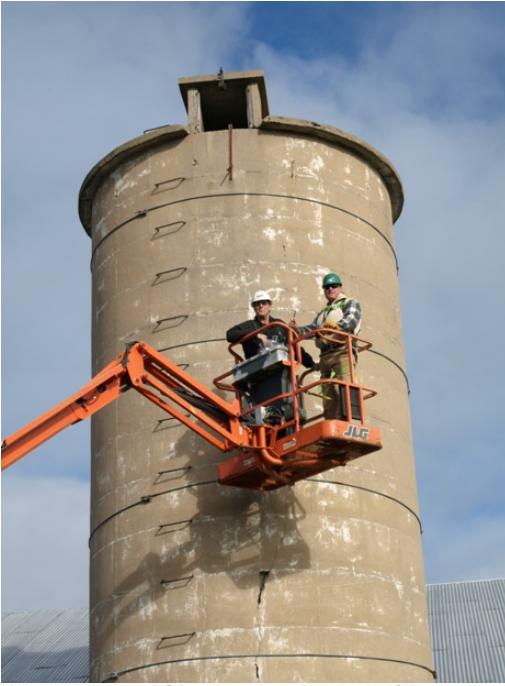
Figure 7: Monolithic concrete silo located in Oconto County, Wisconsin built in 1919. Note the dormer window and the attached ladder. This silo also features reinforcing hoops and due to the weathering of the paint, the slip form seams are now visible.

The final concrete construction method was that of the monolithic silo. (Figure 7) The monolithic silo was one solid tube of

concrete, poured more or less at the same time resulting in a seam free and remarkably solid structure. With the monolithic construction technique, air leaks were no longer a concern and exterior structural support was no longer necessary. These silos could last almost indefinitely with minimal to no maintenance. Monolithic silos proved to be especially popular and came to replace other silo construction techniques as the preferred method. Construction costs were comparable with other methods and required only the use of slips and concrete supplies.¹⁸

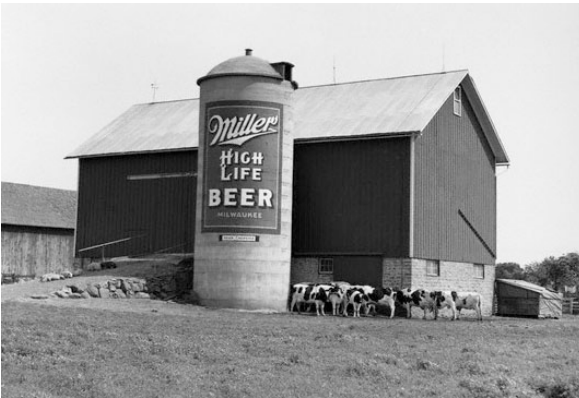
Figure 8: A slip-form concrete silo located near Madison, Wisconsin. Photo taken July, 1937.

The monolithic silo appeared across the Midwest as well as the rest of the country. They were easy to discern from other construction techniques due to their clean outward appearance. Monolithic silos had no exterior supports; the reinforcement was all located within the concrete itself, eliminating the hoops seen in many other techniques. They also usually featured an outside dressing that made the silo appear seamless. Of course, some were left unfinished with the slip form marks still visible, but many were finished with a surface coating of cement and paint that created a more finished look. The smooth surface lent itself well to being decorated, and many farmers personalized their silos with personal or commercial messages. (Figure 8) Monolithic construction was the construction technique also used by many grain elevators who took advantage of the large uninterrupted canvas to place their brand name and other advertisements on the exteriors.

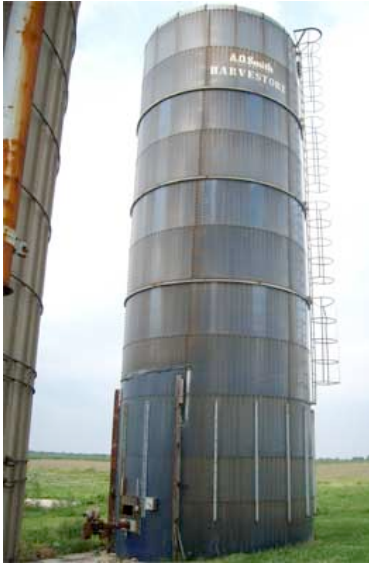
Figure 9: An older Harvestore silo located near Hanna City, Illinois. Note the brilliant blue color which identifies the Harvestore brand.

The final type of silos was the bonded fiberglass silo, commonly known by the brand name "Harvestore." (Figure 9) These silos developed in Wisconsin in response to the long known fact that the removal of air results in the highest quality silage. Harvestore silos were made from fiberglass bonded to curved sheets of steel and then formed into an airtight structure. To allow for atmospheric change, they featured a large bag inside to adjust the pressure. An added feature of the Harvestore was the automated system built in for ease of unloading, which featured an auger that removed silage from the bottom of the silo rather than the top, as in earlier styles. This new feature created two advantages. First, it did away with the need for the outside chute and ladder and farmers no longer needed to climb to the top daily to unload silage. Second, silage could be continuously added to the top of the stack eliminating the need to completely empty a silo before filling it again.¹⁹

Harvestore silos came in a brilliant blue color that made them instantly recognizable from any other silo. The blue color resulted from the inclusion of the mineral cobalt in the glass material which is bonded to the steel. This was a choice based on the availability and affordability

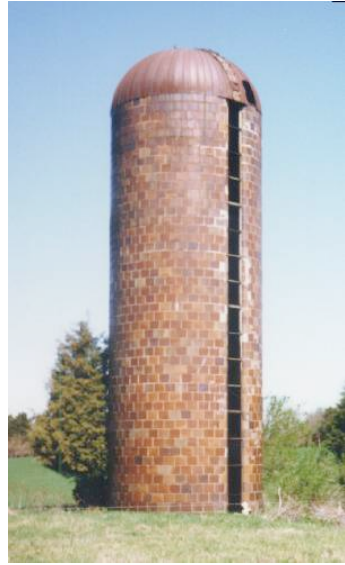
Figure 10: Fired clay tile silo. Note the continuous door slit, which is bridged by reinforcing rods. There is also no visible ladder, so in this case the rods may have served a dual purpose as a ladder as well. Located near Ashburn, Virginia.

Doors on silos also changed greatly over the course of silo evolution. Multiple doors were convenient on silos to access the silage at different levels of fill. Early silos had few or no doors due to construction methods unable to support a hole cut into the side. Early publications noted that if a door was desired, to make sure to not place them over each other to improve the stability of the silo. That was the reason for staggered doors in early constructions. As methods improved, the number and size of doors increased. Eventually the continuous door developed as a long open slit from top to bottom of the silo. (Figure 10) The supporting hoops as seen in wooden and concrete stave construction bridged these slits. This method became the normal practice with the exception of the Harvestore silo, which did not use doors.²⁴
